**PHOTO  
INTERPRETATION  
NOTE**

**NATIONAL PHOTOGRAPHIC  
INTERPRETATION CENTER**

**RECONSTRUCTION, HAI PHONG CEMENT PLANT  
NORTH VIETNAM**

**NPIC/R-47/71**

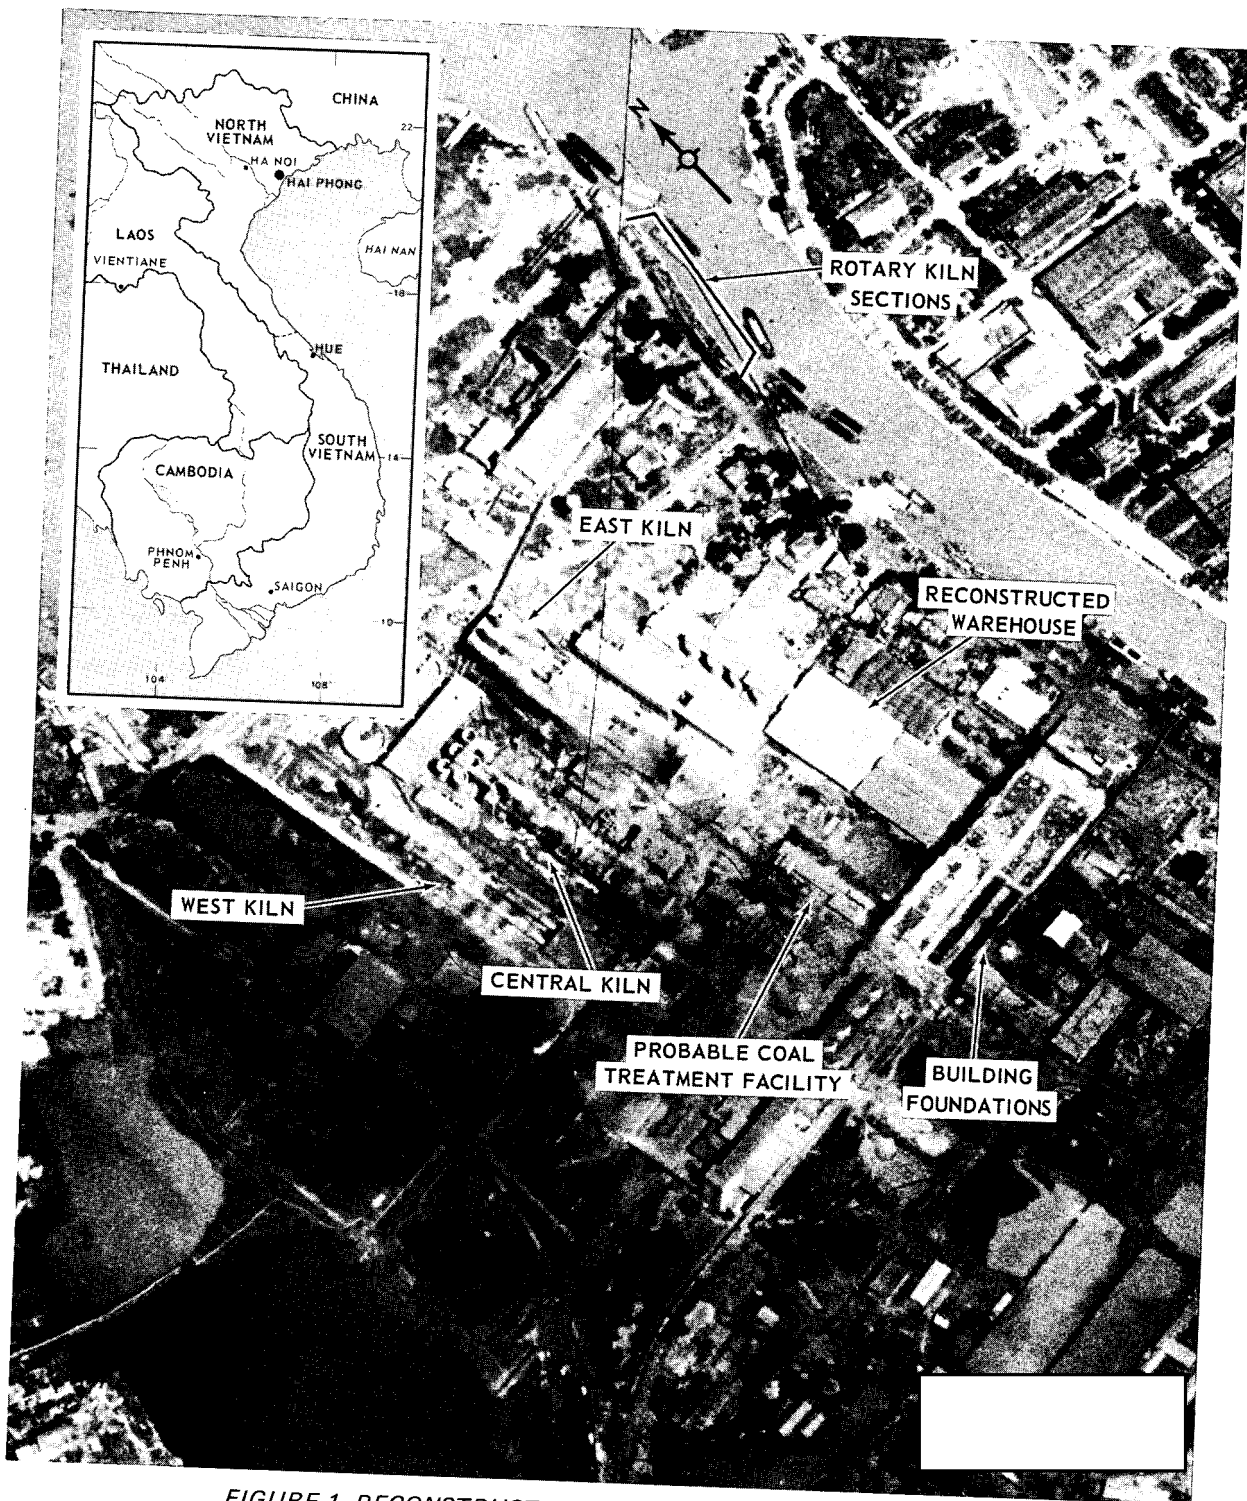
FIGURE 1. RECONSTRUCTION AT HAIPHONG CEMENT PLANT

1. The Haiphong Cement Plant, severely damaged by airstrikes in April 1967, has been almost completely rebuilt. Six of the original seven horizontal rotary kilns were operational

2. Operations at the plant had been entirely stopped because of extensive damage. One of three rotary kiln buildings was destroyed, one was heavily damaged, and the other sustained minor damage. Two clinker storage buildings were heavily damaged and one moderately damaged. The coal treatment plant, the limestone crushing building, several warehouses, and numerous support buildings were moderately to heavily damaged.

3. Reconstruction of the plant has been slow. One kiln of the westernmost kiln building was repaired and operational [REDACTED] This was the first indication of renewed production at the plant. The second kiln of this two-kiln unit was subsequently operational. [REDACTED] all three kilns of the easternmost kiln building were rebuilt and operating. [REDACTED] smoke was coming from the stack of the central kiln building. One of the two kilns of this unit has been repaired and the other has been removed, possibly in preparation for replacement or repair. Thirteen kiln sections were on the transshipment quay to the east of the plant.

4. Other recent reconstruction included the addition of a new probable coal treatment plant, replacement of a previously destroyed large warehouse, and replacement of the damaged roof of the eastern clinker storage building. Foundations for additional new buildings indicated continuing construction at the facility.
